More Than Bread Sanborn Bakery

Client – Valley View Commerce Center LLC

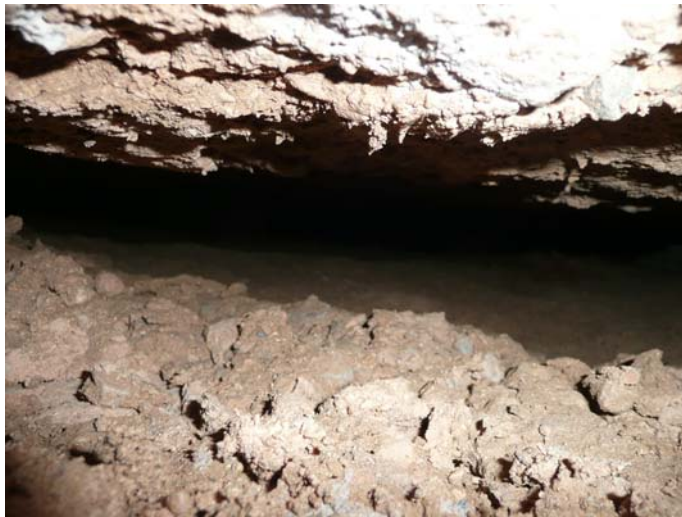
The site includes an existing commercial warehouse, office, and food production building. The building is a concrete tilt up structure with tubular steel interior columns supporting the roof structure, and concrete slab-on-grade floors. Since the construction of the building shell, tenant improvements have been constructed within the building; including interior walls and installation of interior plumbing below the slab. A large portion of the northern half of the building is occupied by a bakery which includes large ovens, mixers, and cooling racks. Settlement and distress of the slab-on-grade floor around a column within the bakery was observed. The distress observed includes cracking of the concrete slab-on-grade floor and dry wall near the column.

GES will evaluate the relative difference in the top of slab elevation around the column using a manometer; up to 3 manometer surveys are anticipated. The concrete slab-on-grade will be cored within the zone of distress and the thickness of the concrete and supportive aggregate base will be measured. An exploratory boring will be drilled to a depth of approximately 30 feet below the existing slab-on-grade surface using a track mounted limited clearance drill rig and hollow-stem augers. Relatively undisturbed subsurface soil samples will be obtained using a California sampler lined with rings. Ring samples will be obtained throughout the upper ten feet of the subsurface soils. Laboratory testing including unit weight, moisture, solubility and hydrocollapse potential will be performed. GES will submit a report to our client which will include the results of our analysis regarding the observed distress and present recommendations for remediating the distress.
