## **Valley View Commerce Center**

Client – Valley View Commerce Center LLC

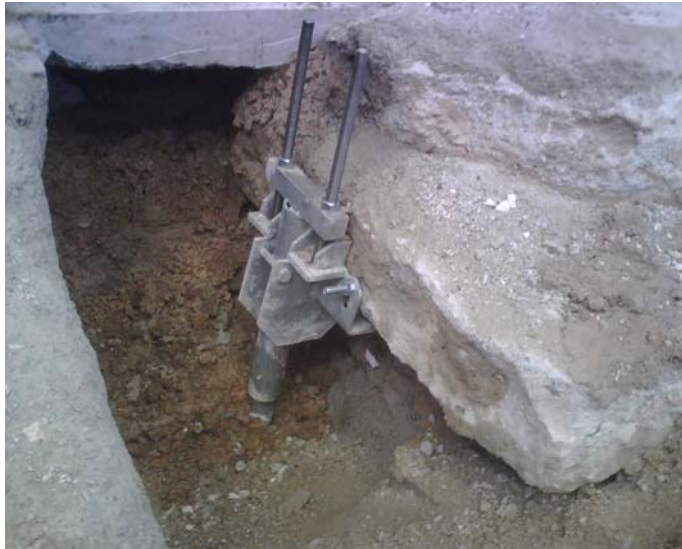
The site includes an existing commercial warehouse, office, and food production building. The building is a concrete tilt up structure with tubular steel interior columns supporting the roof structure, and concrete slab-on-grade floors. Since the construction of the building shell, tenant improvements have been constructed within the building; including interior walls and installation of interior plumbing below the slab. A large portion of the northern half of the building is occupied by a bakery which includes large ovens, mixers, and cooling racks. Settlement and distress of the slab-on-grade floor around a column within the bakery was observed. The distress observed includes cracking of the slab-on-grade floor and dry wall near the column.

GES observed the helical pier load test and prepared a summary report of our observations based on the helical pier load test. We observed installation of the helical piers at an interior column in the building and will prepare a QAA letter for submittal to CCDDS. GES observed the replacement of loose, wet subsurface soils with Type II aggregate base; GES measured the moisture and density of Type II placed. We observed rebar layout and concrete placement at a section of the slab-on-grade that was removed.
